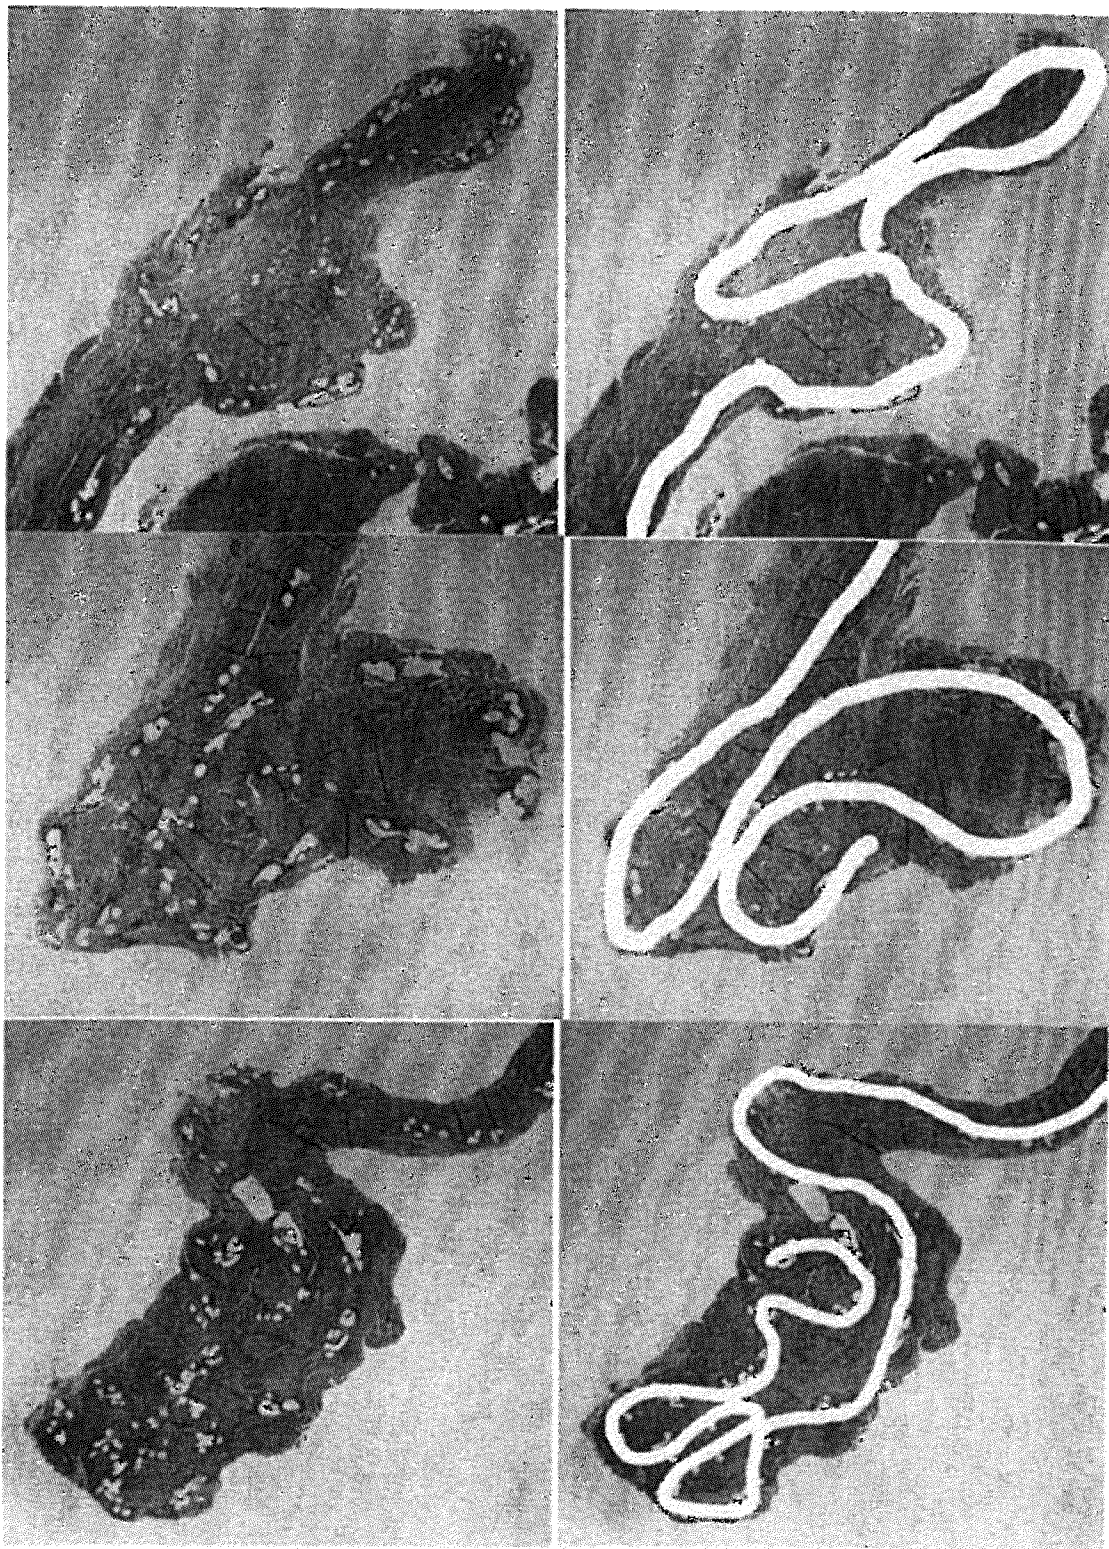
Figure 14. Several examples of mesh deformation.
